Relative Performance Comparison Between Baseline Labyrinth and Dual-Brush Compressor Discharge Seals in a T-700 Engine Test

Prepared for the
39th International Gas Turbine and Aeroengine Congress and Exposition
sponsored by the American Society of Mechanical Engineers
The Hague, Netherlands, June 13-16, 1994

RELATIVE PERFORMANCE COMPARISON BETWEEN BASELINE LABYRINTH AND DUAL-BRUSH COMPRESSOR DISCHARGE SEALS IN A T-700 ENGINE TEST

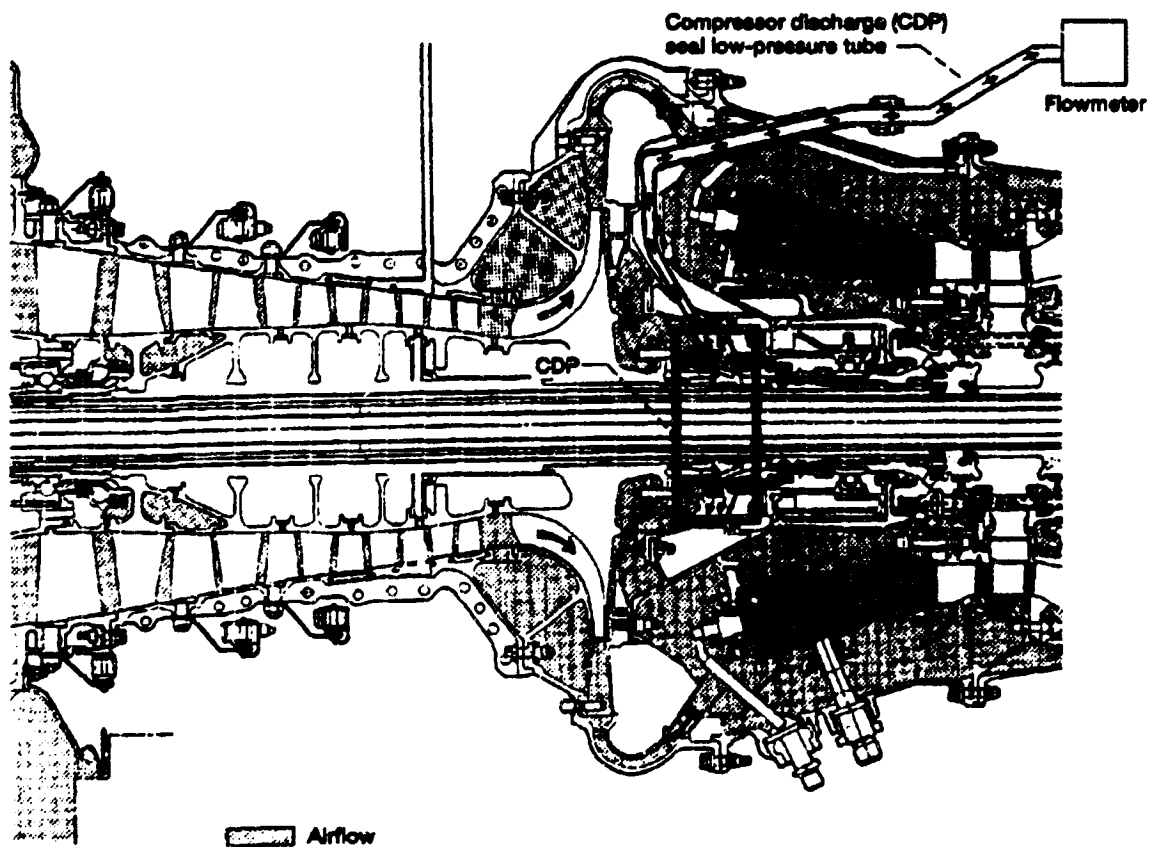
(a) Airflow schematic.

Figure 1.—Schematic of engine airflow and location of flowmeter.

The power stream airflow through the compressor and the secondary airflow leakage past the compressor discharge seal (CDP) are illustrated in Fig. 1(a), and the CDP viscous-tube flowmeter is shown in Fig. 1(b). The compressor discharge seal package and associated drain tube are located immediately downstream of the impeller and labeled CDS. The drain tube was opened after a series of runs and swabbed for debris.

During the test series the drain pipe (Fig. 1) was swabbed for debris. When these samples were in turn investigated with a scanning electron microscope (SEM), nickel, chromium, and tungsten lines were observed along with other unexplainable peaks of salts (e.g., Fig. 12). The nickel, chromium, and tungsten lines characterize bristle materials and some possible coating wear. The debris was fine and difficult to locate and isolate within the tube. Other metal sources and rubbing surfaces could have also produced such debris, but we attributed it to bristle wear.

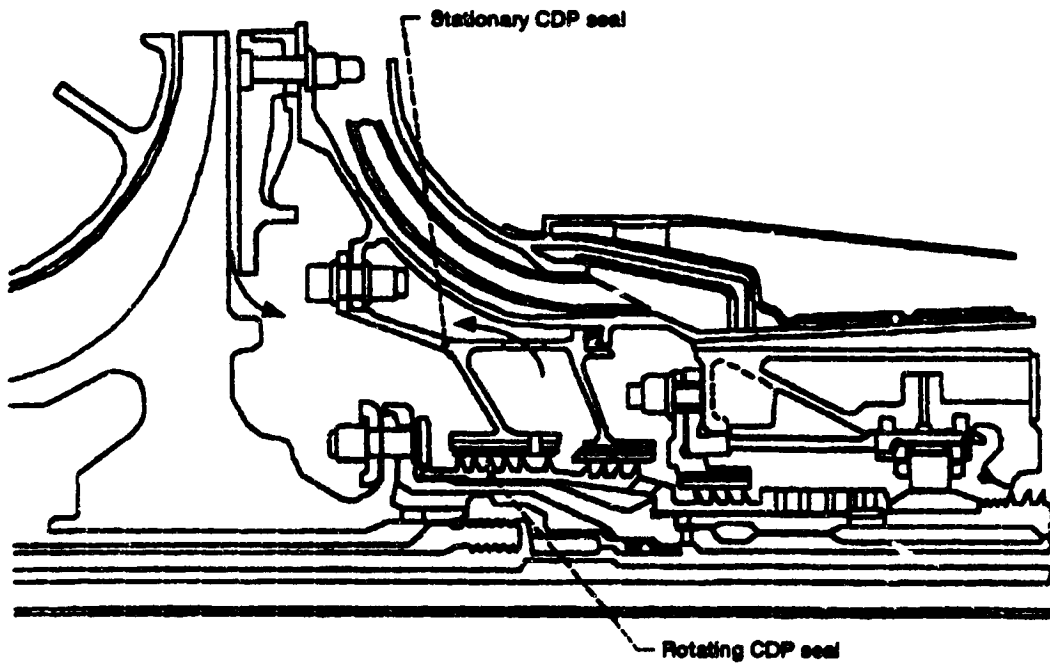
(a) Labyrinth seal package and airflow.

Figure 2.—Labyrinth compressor discharge seal system.

The labyrinth CDP seal package and airflow path are shown in Fig. 2(a). The nominal 71-mm (2.8-in.) diameter forward-facing labyrinth seal system is illustrated in Fig. 2(b). The labyrinth teeth rub into a felt-metal type of interface, forming the seal system. Note that the teeth are not all forward facing and are used in different ways to satisfy different engine operating requirements. A simulated exploded view of the seal system is given in Fig. 3 and clearly illustrates the forward-facing teeth of the rotor. However, the housing shown in the figure is for the brush seal.

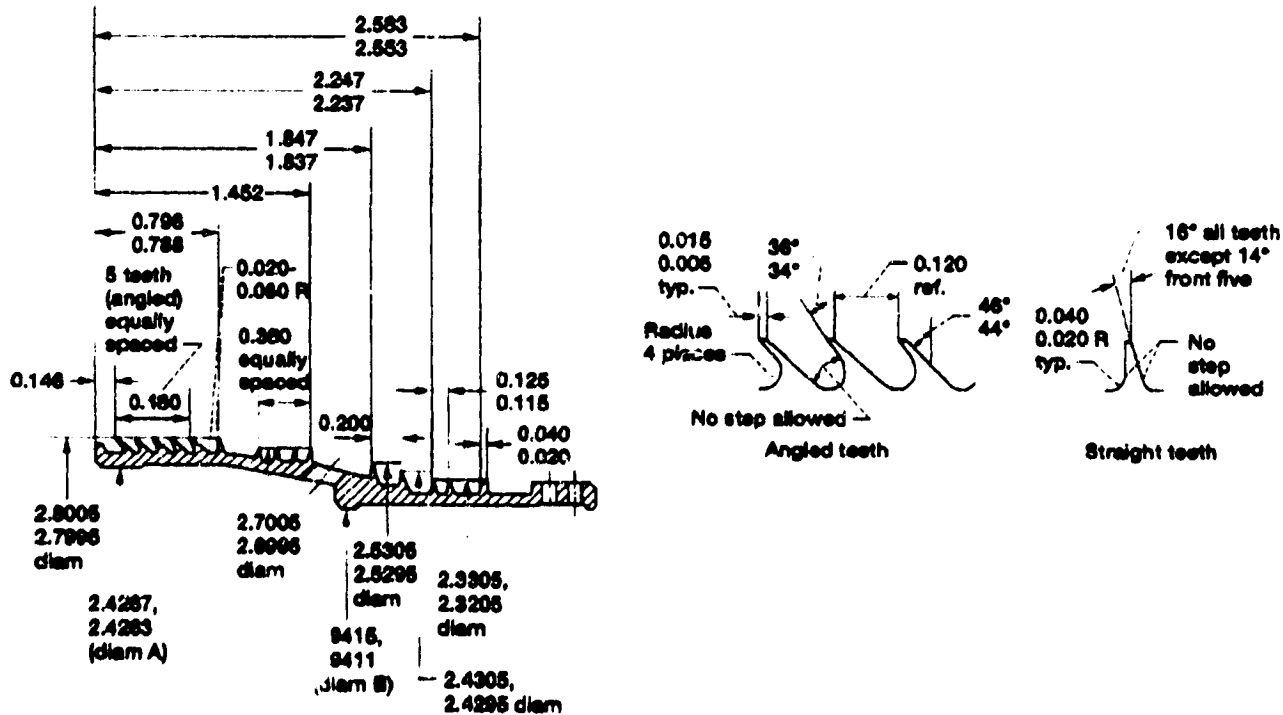
(b) Schematic of labyrinth compressor discharge seal. (Seal teeth and axis established by diameters A and B to be concentric within 0.003 full indicator reading. No steps allowed on tooth face or at fillet radius. All dimensions are in inches.)

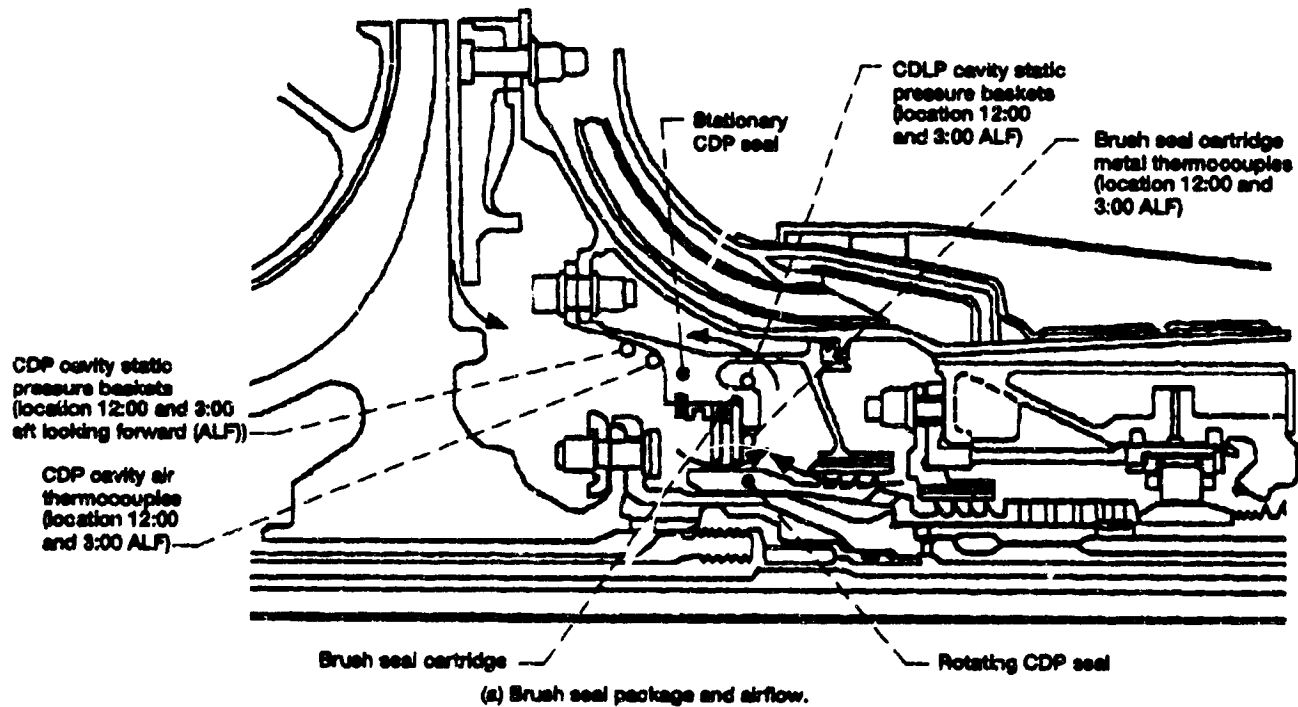
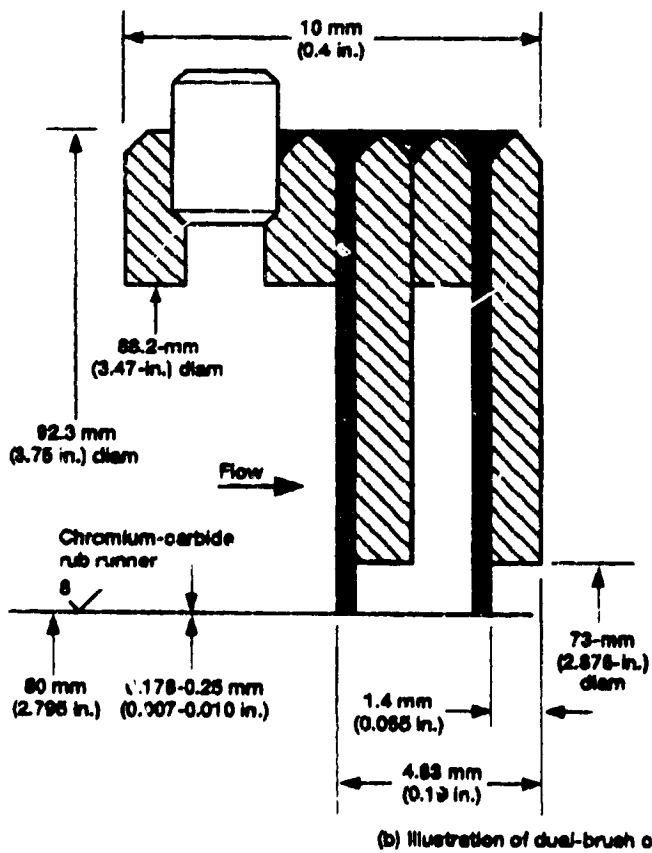
Figure 4.—Dual-brush compressor discharge seal system and schematic of airflow.

The dual brush was selected over a single brush for reliability of a critical engine component, distribution of the pressure drop per brush, and mitigation of wear. The dual-brush CDP seal package and airflow path are shown schematically in Fig. 4(a) and illustrated in Fig. 4(b). The dual brush, nominally 71 mm (2.8 in.) in diameter, runs against a 0.178- to 0.254-mm (0.007- to 0.010-in.) thick, smooth (8 rms) chromium-carbide-coated rub runner interface as shown schematically in Fig. 4(c). (See also Figs. 11(b) and (c) between wear scars.) The basic seal system was envisioned by General Electric and manufactured by Cross Mfg. Ltd. (Flower, 1990). It has 0.071-mm (0.0028-in.) diameter, Haynes 25 bristles angled 43° to 50° to the interface with approximately 98 to 99 per millimeter of circumference (2500 per inch of circumference) and a nominal interference fit of 0.127 mm (0.005 in.) at installation. Brush seal design conditions include surface speed of 168 m/s (350 ft/s), temperature of 740 K (870 °F), pressure drop of 0.6 MPa (84 psi), and bristle deflection of 0.64 mm (0.025 in.). Figure 5 gives a post-test exploded view of the brush seal system with associated instrumentation lines (cut after testing). Figure 6 provides a side-by-side comparison of the forward-facing labyrinth seal (right) and the chromium-carbide-coated rub runner replacement (left); these represent the rotating interface. This design could be enhanced by using an upstream "washer" to mitigate foreign object damage and by optimizing the backing washer thickness and profile to pressure loading to mitigate hysteresis.

Pretest and post-test photographs of the dual brush and its installation in the seal system are shown in Figs. 4, 5, and 7. Figure 4(b) depicts the dual brush prior to and Fig. 5 after testing. Figure 7(a) shows the upstream view of the instrumented housing; four thermocouples are attached to the side plates with upstream and downstream pressure taps. Figure 7(b) shows a direct view from the downstream side, and Fig. 7(c) is an isometric view showing the "shiny" nature of the bristle interface. Many seal dimensions and coating and installation details are proprietary.

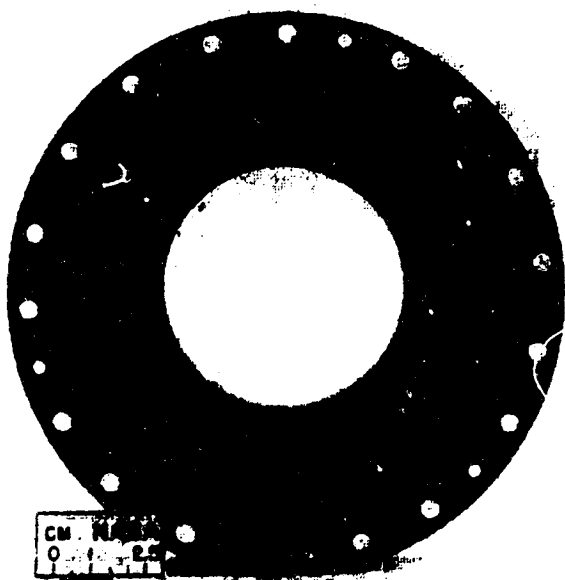
C-93-02710

(a) Upstream view.

Figure 7.—Dual-brush compressor discharge seal system after testing.

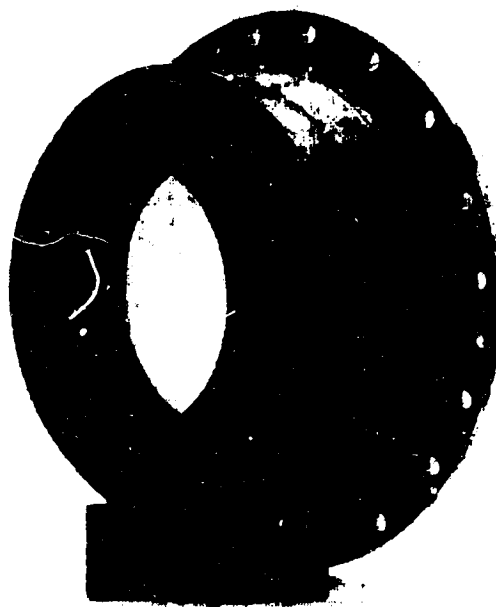
C-93-02712

(b) Downstream view.

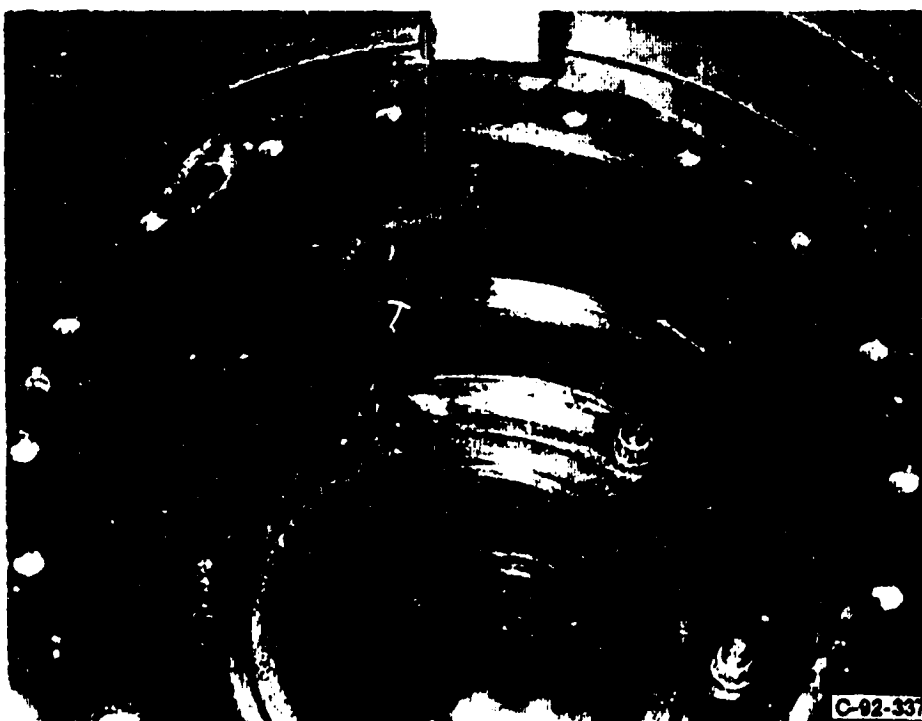
(b) Seal package cavity and housing.

Figure 8.—Dual-brush seal package installation.

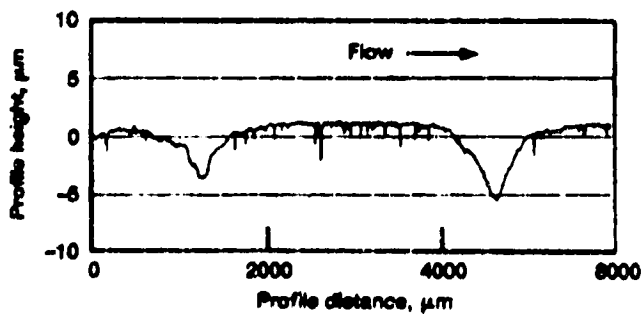
(b) Discharge seal profile showing slight wear scars.

Another variation in the wear pattern is attributed to the rotor machining or coating variations (Fig. 11(a)). The rotor showed a small eccentricity and was investigated for metallic transfer, but no significant transfer was found. The chromium carbide interface was worn smoother by the rubbing brush bristle interface, implying some form of wear or material smearing without significant transfer of the chromium carbide (CrC is usually a plasma-sprayed mixture of Cr_3C_2 and Cr_7C_3 ground and polished to form the rub-runner surface). The CrC-coated rub runner exhibited slight wear scars but no spallation or coating degradation otherwise, as illustrated in Fig. 11(b); however, eccentric operations, startup, or a hard rub caused a deeper scar over about 120° of the rotor as shown in Fig. 11(c). These wear bands are readily visible in Fig. 6, where the upper band is associated with the upstream (p_{max} , pressure side) brush; see also Figs. 5 and 8.

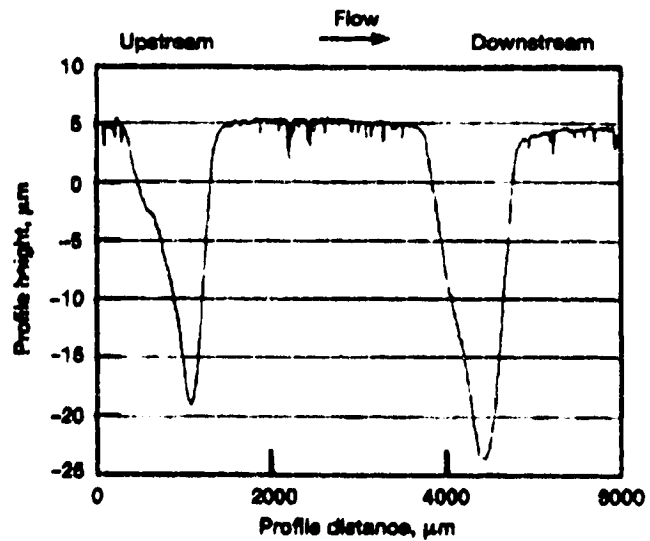
(c) Discharge seal profile showing deeper wear scars.

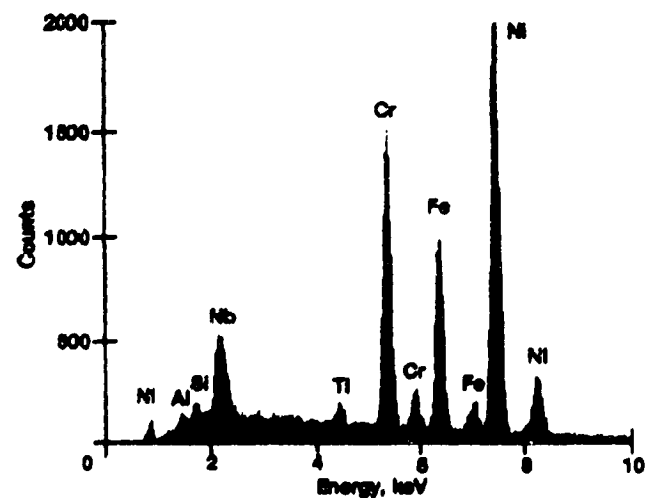
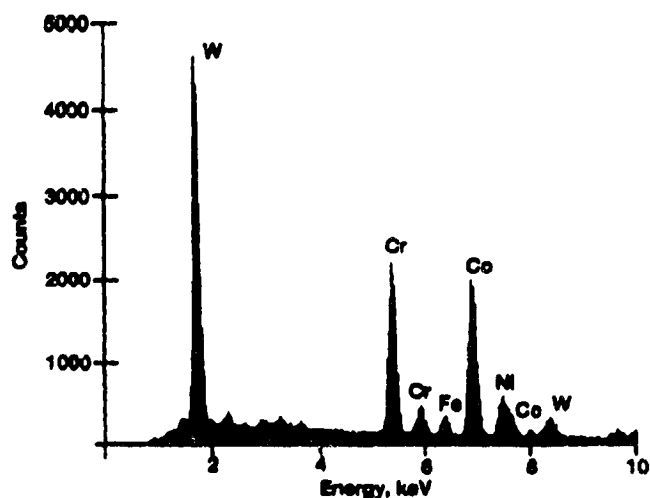
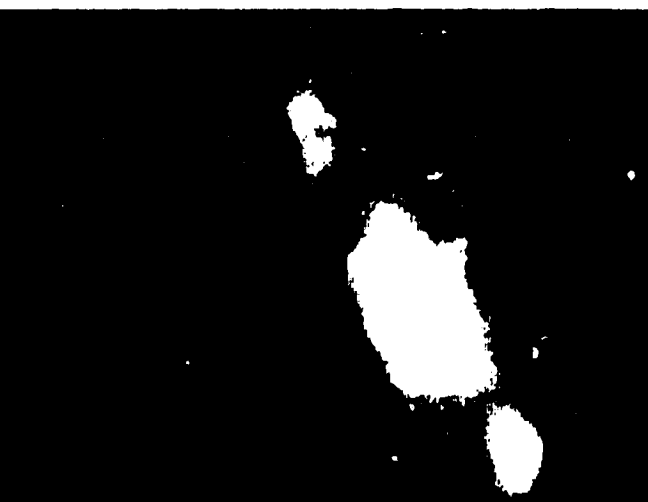
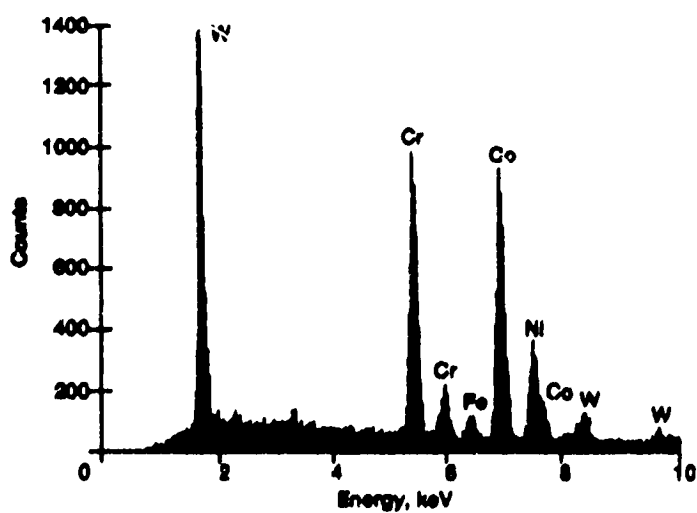
(a) Particle A.

(b) Particle B.

(c) Particle C.

Figure 12.—SEM peaks associated with drain pipe debris.

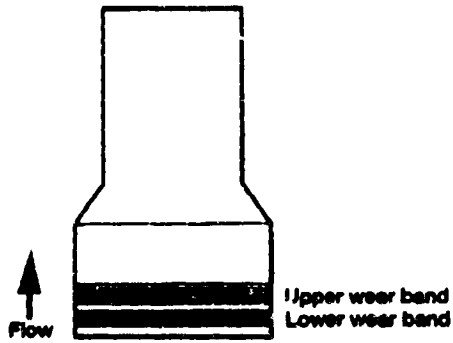
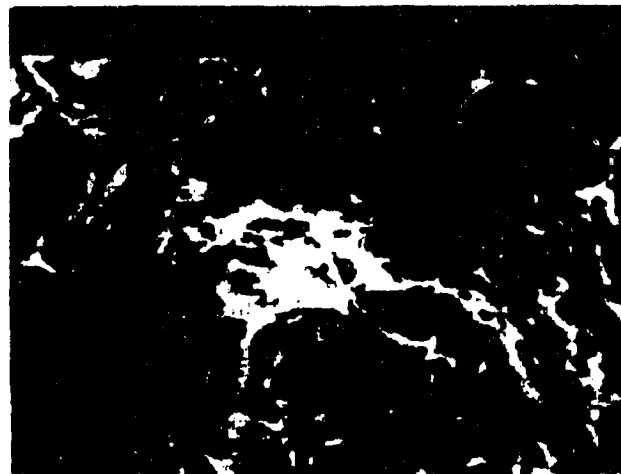
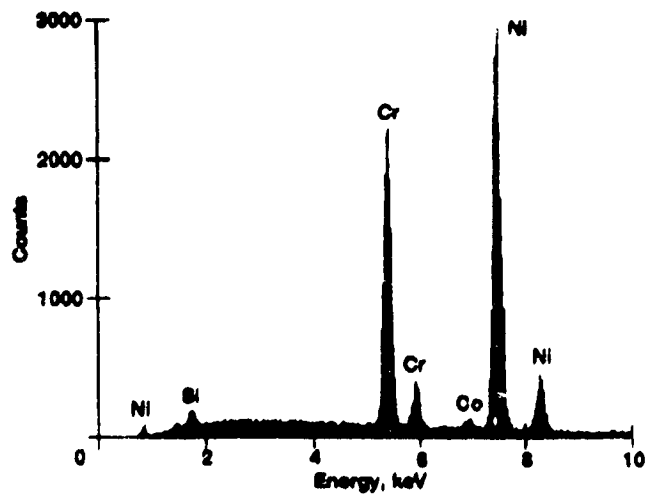
(a) Upstream (lower) wear band.

(b) Downstream (upper) wear band.

(c) Light area in coating matrix between bands.

Figure 13.—EDS peaks associated with chromium-carbide-coated rub runner.

The upstream wear surface of the rub runner is characterized by Fig. 13(a) and the downstream wear surface by Fig. 13(b). The CrC coating is characterized by light and gray areas, and the energy spectrum shows the light areas to be an NiCr composition and the gray areas to be predominantly Cr. The light and gray areas of the matrix or unrubbed material between the bands is illustrated in Figs. 13(c) and (d). Similarly, for the upstream wear band in Figs. 13(e) and (f) and for the downstream wear band in Figs. 13(g) and (h). There appears to be no material transfer from the bristles to the rotor and only minor scarring and polishing.

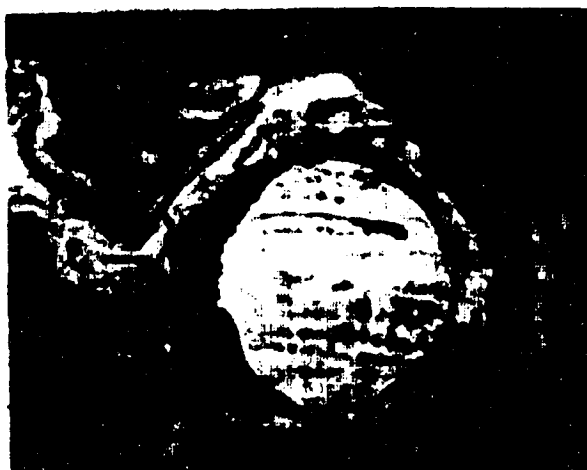
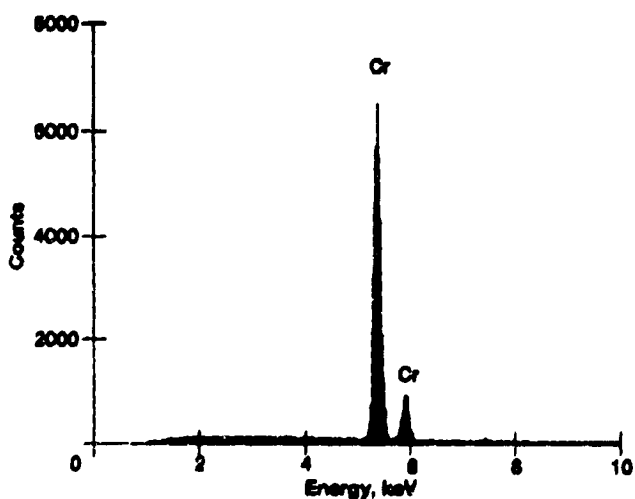
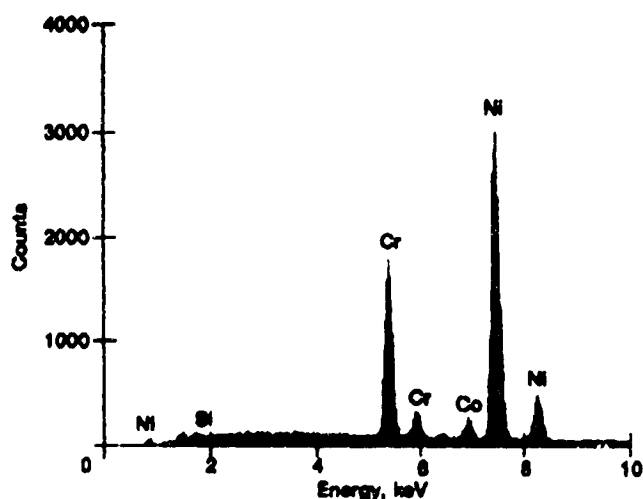
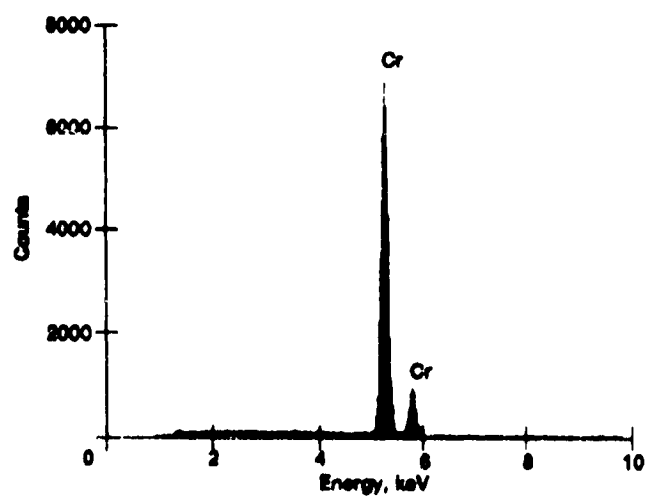
(d) Gray area in coating matrix between bands.

(e) Light area in upstream (lower) wear band.

(f) Gray area in upstream (lower) wear band.

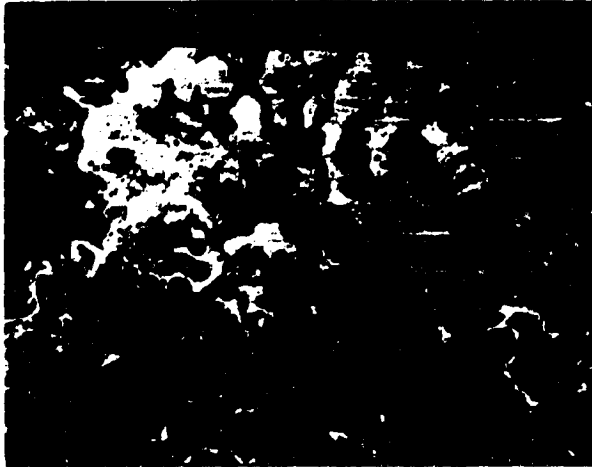
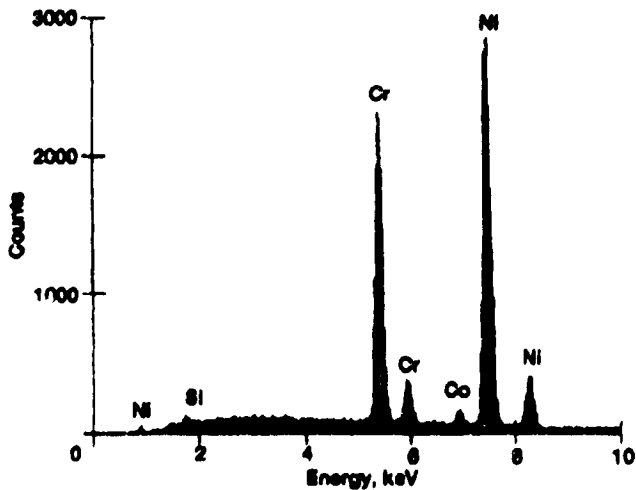
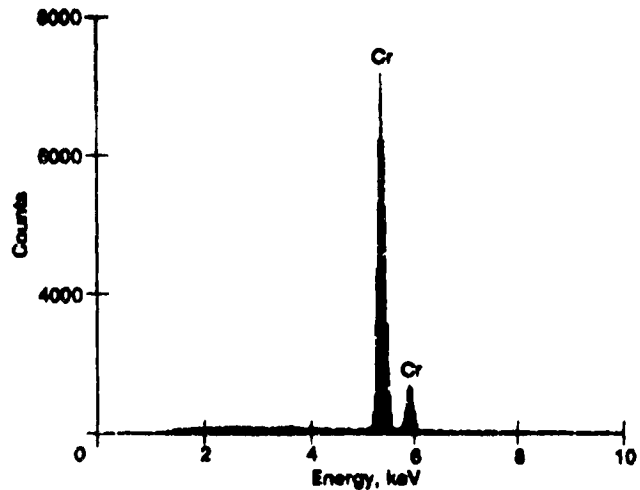
(g) Light area in downstream (upper) wear band.

(h) Gray area in downstream (upper) wear band.

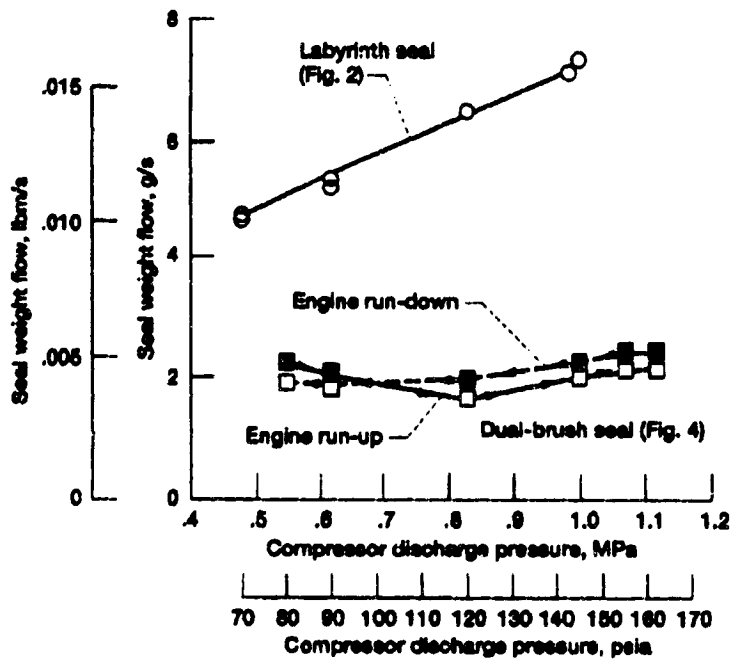
Figure 14.—Seal weight flow as a function of compressor discharge pressure for labyrinth and dual-brush seals.

Representative seal leakage variations as a function of compressor discharge pressure are given as Fig. 14, with calculation parameters in Table I. (See Fig. 1(b) for the location of the flowmeter.) Readings 42 to 111 are labyrinth or baseline seal data; readings 331 to 342 are dual-brush seal data. On the average the labyrinth seal leakage is 2.5 times more than the dual-brush seal leakage and strongly depends on pressure relative to the dual brush. Increasing pressure tends to pack the dual-brush seal; leakage flow decreases to approximately 0.83 MPa (120 psi) and then increases. (It also stiffens the bristles and increases wear.) The pressure drops for each comparable compressor discharge pressure setting were higher for the brush seal system than for the labyrinth seal system (Tables I to III). For the same engine operating conditions the dual-brush system leaked less than the baseline forward-facing labyrinth seal sys-

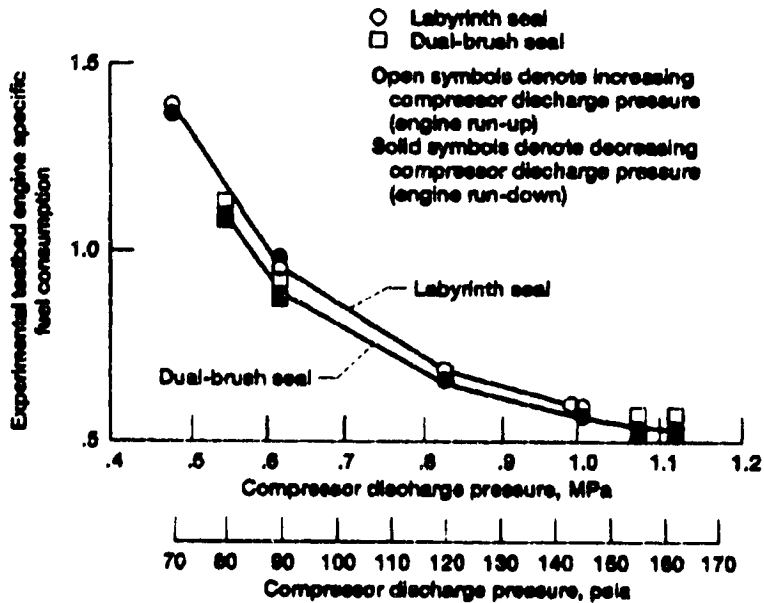
Figure 15.—Experimental testbed engine specific fuel consumption as a function of compressor discharge pressure with labyrinth and dual-brush seals.

tem. Also implied is enhanced engine efficiency. However, a decrease in experimental testbed engine specific fuel consumption (3 percent at compressor discharge pressures of 1 MPa (145 psi) to 5 percent at 0.62 MPa (90 psi)) was found (Fig. 15, Table IV). Variation of experimental testbed specific fuel consumption with horsepower is given in Fig. 16. To within the error estimates the performance increase is assumed to result from less leakage and enhanced distribution of secondary airflow through the engine.

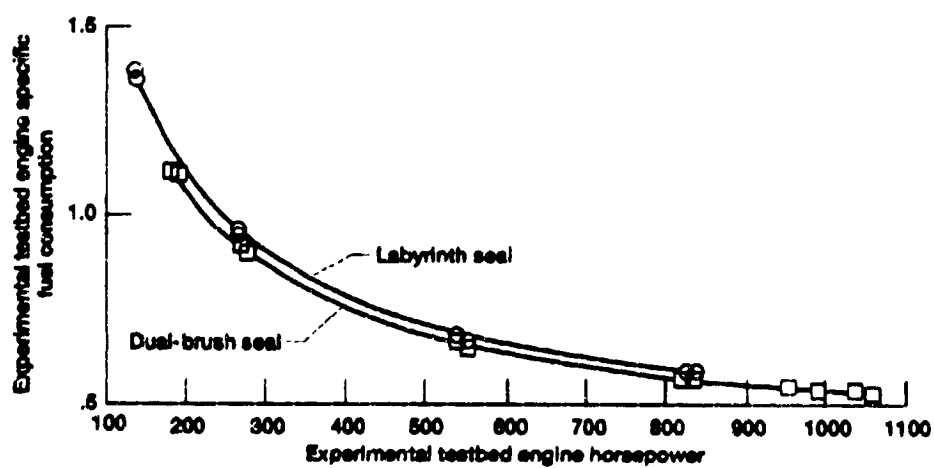
Figure 16.—Experimental testbed engine specific fuel consumption as a function of horsepower.
